## THERMAL AGING EFFECT ON MECHANICAL PROPERTIES OF 30% GLASS FIBER REINFORCED POLYAMIDE 11

**ABSTRACT:** This study investigates the effects of artificial thermal aging on the mechanical properties of 30% glass fiber-reinforced Polyamide 11 (PA11-GF30). Tensile and compression tests were conducted on specimens aged at 125°C, 150°C, and 175°C for up to 4152 hours. The results indicate a progressive decline in mechanical properties, with tensile strength decreasing from an initial 104.6 MPa to 92.63 MPa (12.4% reduction) at 125°C, 73.96 MPa (34.3% reduction) at 150°C, and 74.36 MPa (33.8% reduction) at 175°C. Similarly, compressive strength declined from 135.59 MPa to 122.81 MPa (9.4% reduction) at 125°C, 124.28 MPa (8.3% reduction) at 150°C, and 104.76 MPa (22.7% reduction) at 175°C. Notably, an initial strengthening phase was observed due to post-crystallization, particularly at lower temperatures. Elongation at break exhibited a sharp decline, confirming the transition from ductile to brittle behavior, with samples at 150°C and 175°C reaching the 5% brittleness threshold after 2016 hours and 1344 hours, respectively. These findings provide critical insights for the design and ap

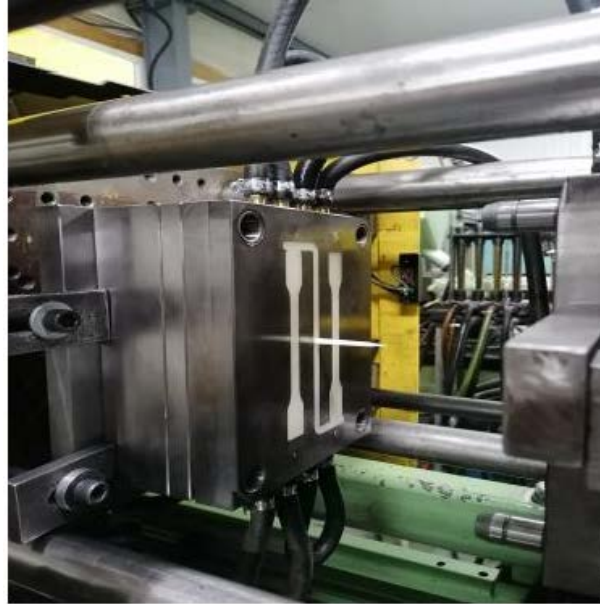
Fig. 1. Multipurpose specimens manufacturing from PA11 resin.

The samples used for the thermal aging experiment were produced by injection molding using the Arburg 270 M molding machine shown in Fig. 1.

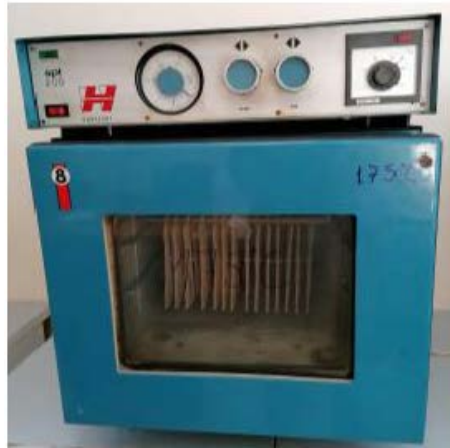
Fig. 2. Arrangement of specimens into drying oven.

The samples are arranged within the aging oven in a manner that ensures equal exposure to the temperature conditions as shown in Fig. 2.

Each specimen is positioned so that it does not touch the others, allowing uniform exposure to the oven temperature and preventing any shadowed areas on individual specimens.

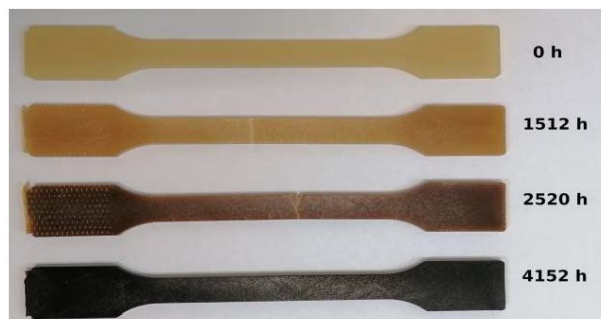
Fig. 3. Samples of PA11 exposed to accelerated aging at 125°.

The initial visible change observed after accelerated dry aging was the color shift (yellowing) in PA11 shown in Fig. 3.

This phenomenon has been already reported in studies dealing with thermo-oxidative degradation and photo-degradation [10–12]. According to literature data the yellowing of polyamide materials is mainly caused by the formation of pyrrole derivatives [10–12] or conjugated enamine or enone groups [11, 13]. Due to the degradation process, tested samples move from uncolored ones to yellow and finally turn to black

as reported by Rudzinski et al. [11]. After 4000 hours the specimens became black at 125°C. At 150°C and 175°C the specimens became black after the first 500 hours.

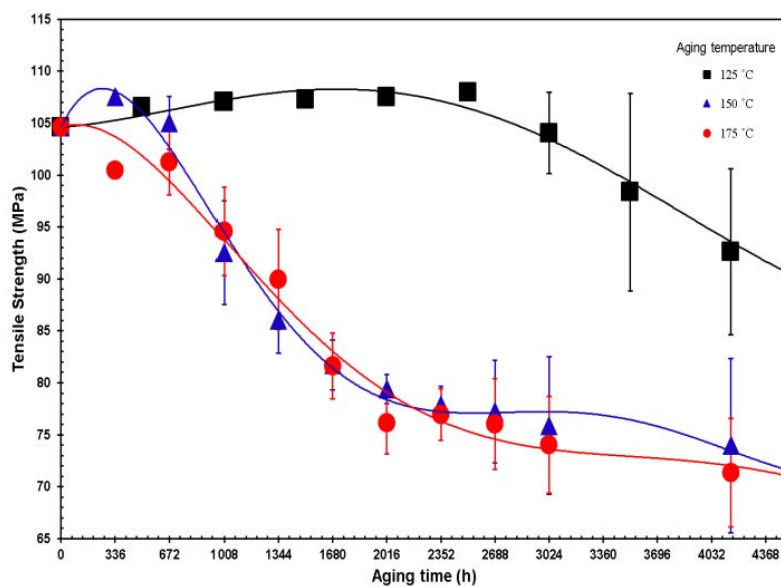
Fig. 4. Tensile strength over aging time.

The stress-strain results analysis revealed significant aging-dependent variations across the three test temperatures shown in Fig. 4. The tensile strength of PA11 decreased over the aging period, with distinct trends observed for each temperature.

Unaged specimens started with an initial tensile strength of 104.6 MPa, closely aligning with manufacturer specifications of 117 MPa [4].

At 125°C, PA11 initially exhibited a minor strengthening phase, reaching 3.34 MPa above the baseline tensile strength after 2520 hours. This phenomenon is likely due to post-crystallization processes, wherein polymer chains reorganize into more stable crystalline structures during thermal exposure. However, extended aging led to a degradation phase, with the tensile strength dropping to 92.63 MPa at 4152 hours, representing a 12.4% reduction.

Similarly, at 150°C, a transient strengthening phase was observed within the first 336 hours, followed by a more pronounced degradation phase, culminating in a 34.3% reduction in tensile strength (to 73.96 MPa) at 4152 hours. At 175°C, the strengthening phase likely occurred between testing intervals and was not directly observed. By 4152 hours, the tensile strength had decreased to 74.36 MPa, reflecting a 33.8% reduction. These results highlight the accelerated degradation effect of higher temperatures, consistent with the Arrhenius relationship that predicts faster reaction rates at elevated temperatures [7, 10, 13].

Notably, after 3000–4000 hours, the degradation curves for both temperatures 150°C and 175°C become almost asymptotic, suggesting that tensile strength reduction plateaus over time. This indicates that no significant further decrease in mechan-

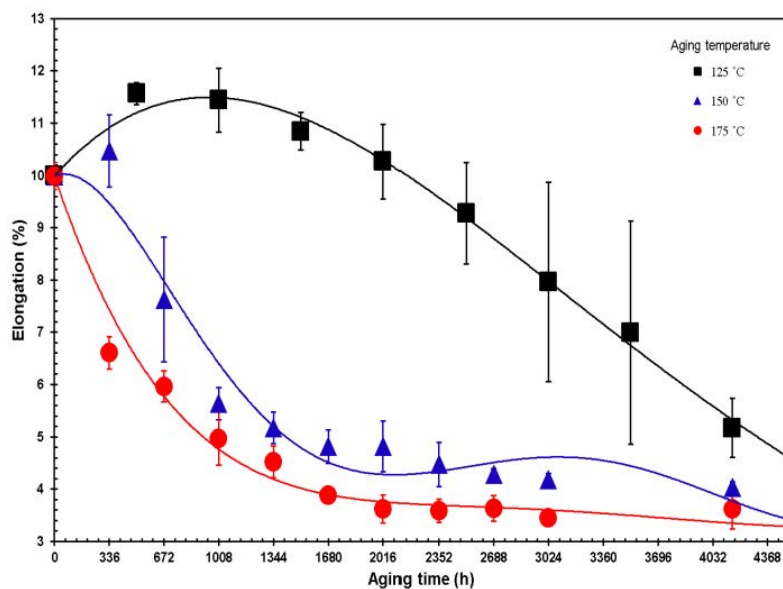
Fig. 5. Elongation at break.

The strain behavior further supports the brittleness transition in aged PA11. As seen in Figure 5, the material crossed the 5% elongation at break threshold, typically defining the brittle material regime. At 125°C, this threshold was reached at 4152 hours, while at 150°C and 175°C, it occurred significantly earlier, at 2016 hours and 1344 hours, respectively. The early onset of brittleness at higher temperatures underscores the temperature-dependent nature of aging in PA11 [11, 13].

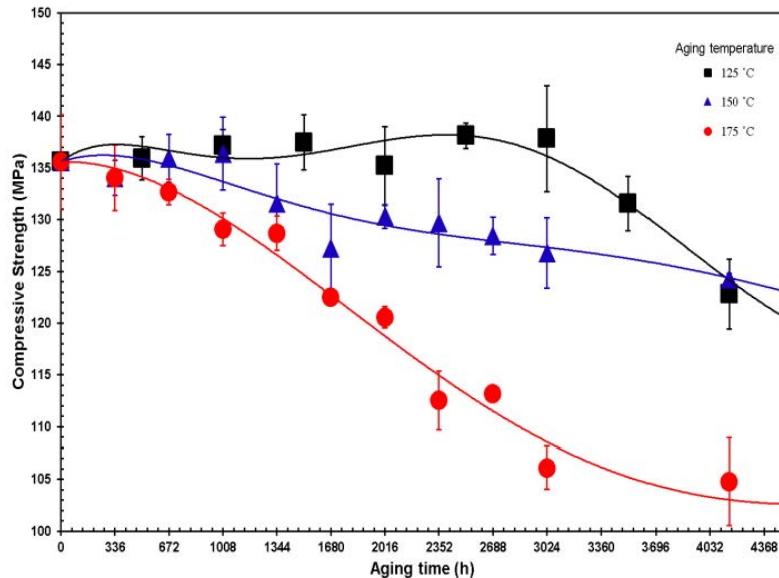
Fig. 6. Compressive strength.

Compression testing revealed an initial compressive strength of 135.59 MPa for unaged specimens. This value is 22.8% higher than the tensile strength of the same material, highlighting the intrinsic resistance of PA11 to compressive forces compared to tensile stresses. Similar to the trends observed in tensile test results, the compressive strength of PA11 decreased over time with thermal aging (Figure 6), reflecting the molecular degradation mechanisms [11, 12].

At 125°C, the compressive strength initially exhibited a minor increase, reaching 138.11 MPa after 2520 hours. This strengthening phase can be attributed to post-crystallization, where molecular chains reorganize into more stable configurations, temporarily enhancing mechanical performance. However, by 4152 hours, the compressive strength had decreased to 122.81 MPa, marking a 9.4% reduction from the initial value.

At 150°C, the material displayed two distinct strengthening zones: between 336 and 1680 hours, and again between 1680 and 2016 hours. These intermittent strengthening phases are consistent with post-crystallization dynamics and localized relaxation of internal stresses induced by thermal exposure. Despite these effects, extended aging led to a compressive strength reduction to 124.28 MPa at 4152 hours, reflecting an overall decrease of 8.3%.

In contrast, at 175°C, the compressive strength steadily declined throughout the aging process without any observable strengthening phases. By 4152 hours, the compressive strength had dropped significantly to 104.76 MPa, representing a 22.7% reduction. This rapid degradation aligns with the accelerated aging effects of higher temperatures, wherein the rate of molecular degradation surpasses any temporary gains from post-crystallization [11, 13].
